An Assessment of Visual Testing

Pacific Northwest National Laboratory

**U.S. Nuclear Regulatory Commission
Office of Nuclear Regulatory Research
Washington, DC 20555-0001**

Manuscript Completed: November 2004
Date Published: November 2004

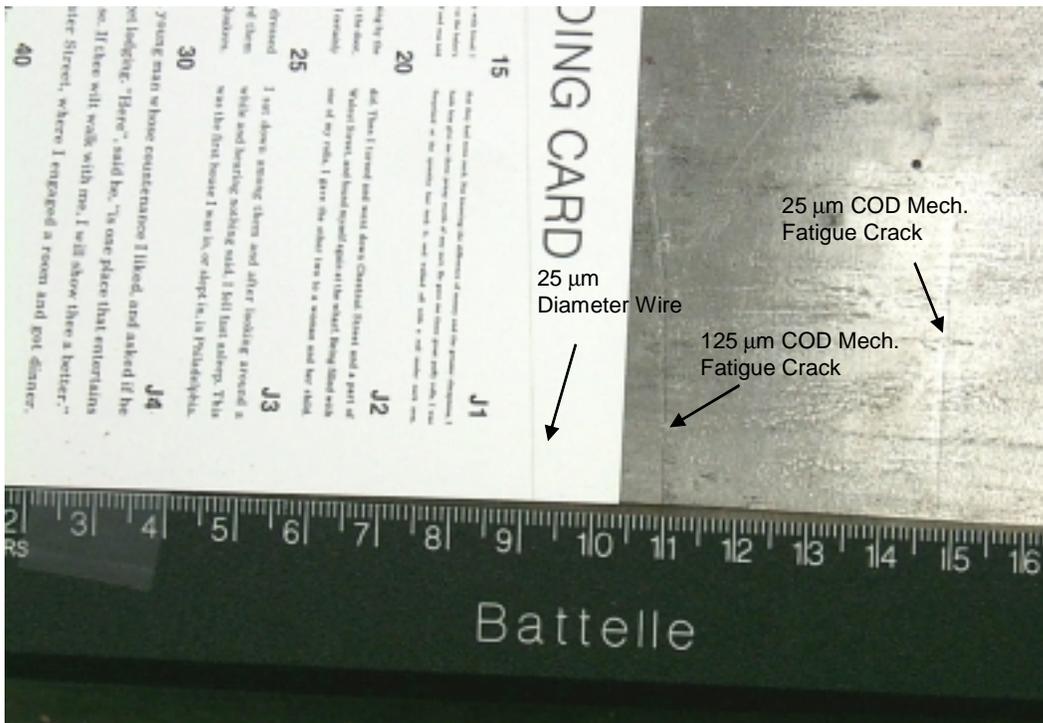
Figure A.6 Sample 4 with Jeager Reading Chart and a 25- μm Diameter Wire

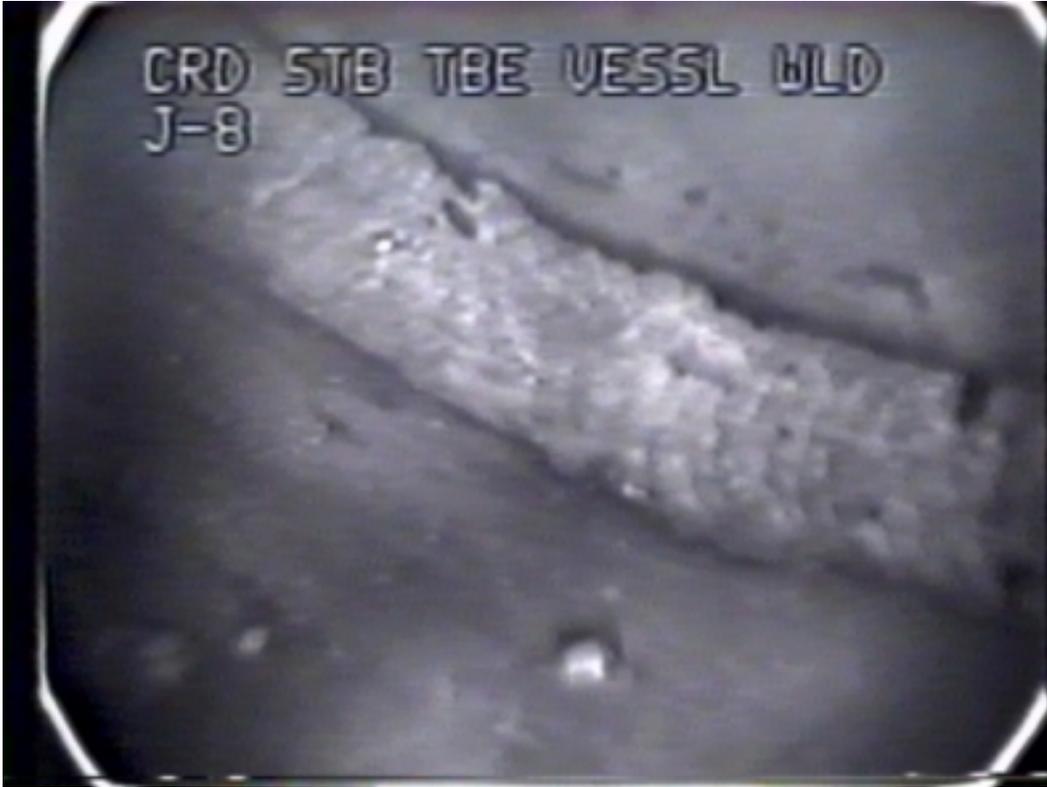
Figure A.7 Frame Capture from Videotaped Visual Inspection of a Control Rod Drive Stub Tube Weld. Note the relatively soft focus.

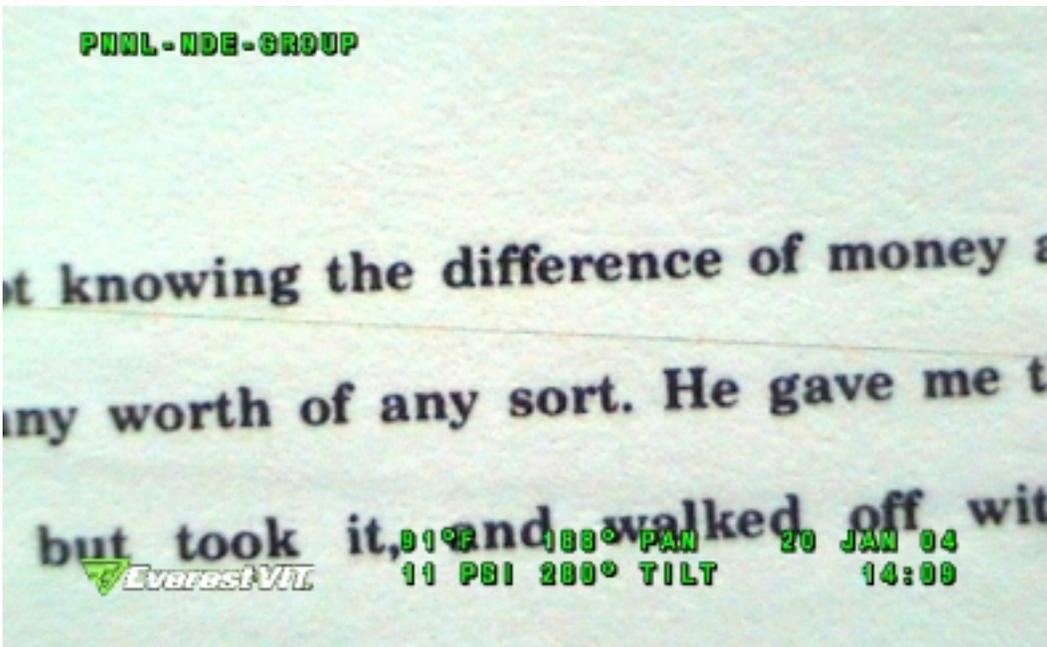
Figure A.8 Closeup of a Jeager Reading Chart and 25- μm Diameter Wire using CaZoom PTZ Camera. The wire is still less than 1 pixel wide.
